# Lasers status since 23 May

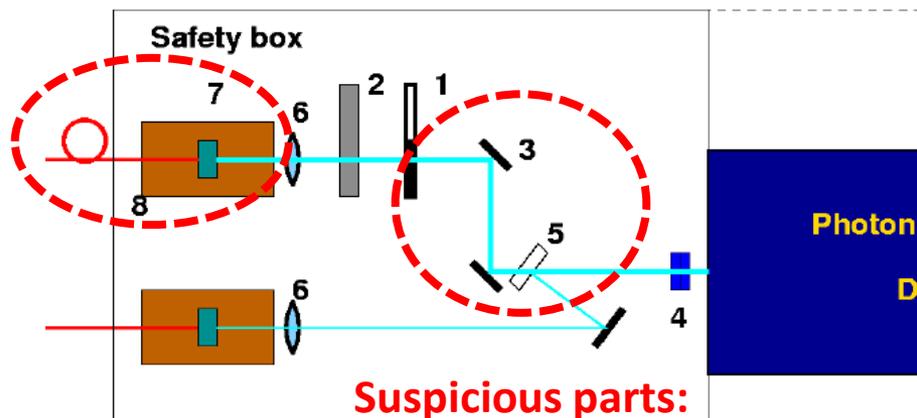
Power is quite consistent with 16 May and the power loss since 16 May doesn't explain the overall loss since 26 April. → 2 suspicious places : from optics but also from fibre again.

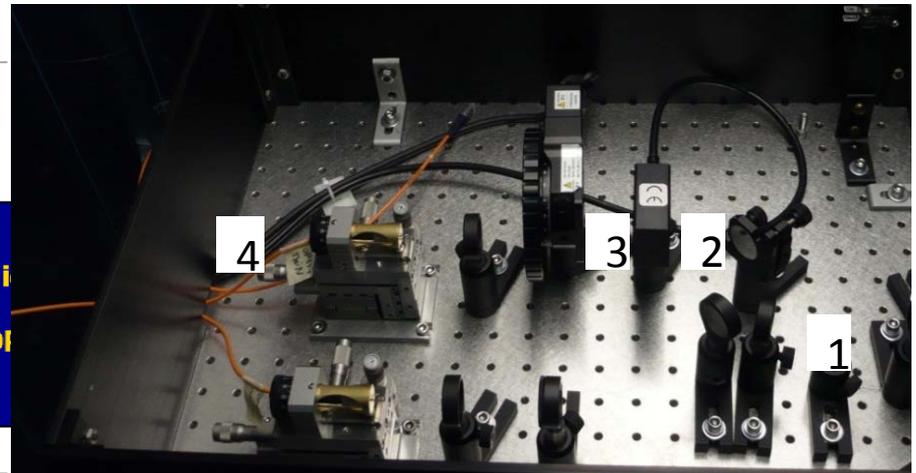
**2 Fold mirrors & Beam sampler**

**Suspicious parts:**

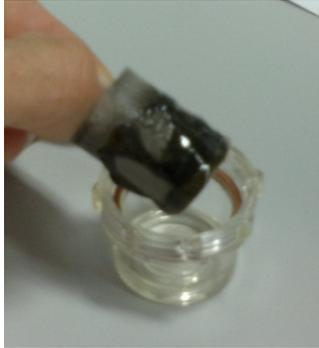
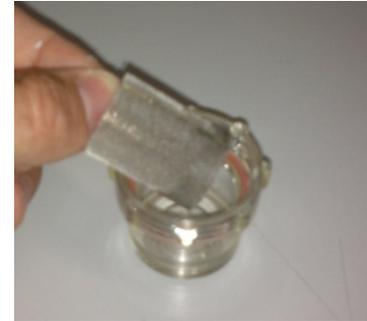
Chiller filter found with dust:

**From Photonics: this condition is not a good sign; an indication of algacide.**

But Non-foaming algacide added to the coolant at time of CERN installation ! Under investigation..
