Lasers Technical stop 25 April

Laser power measurement campaign to understand lasers power level:

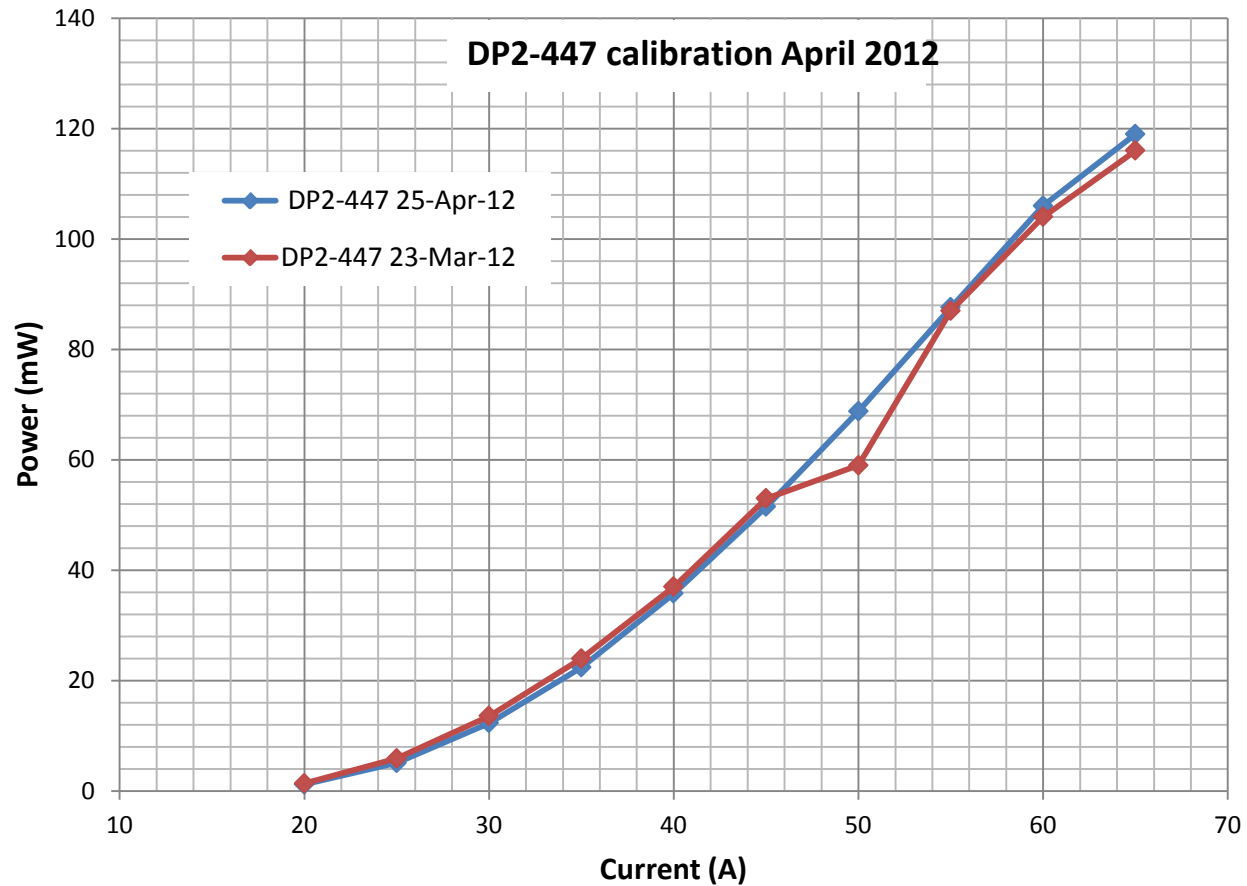
Photonics calibration curve :

Working point: 55 A

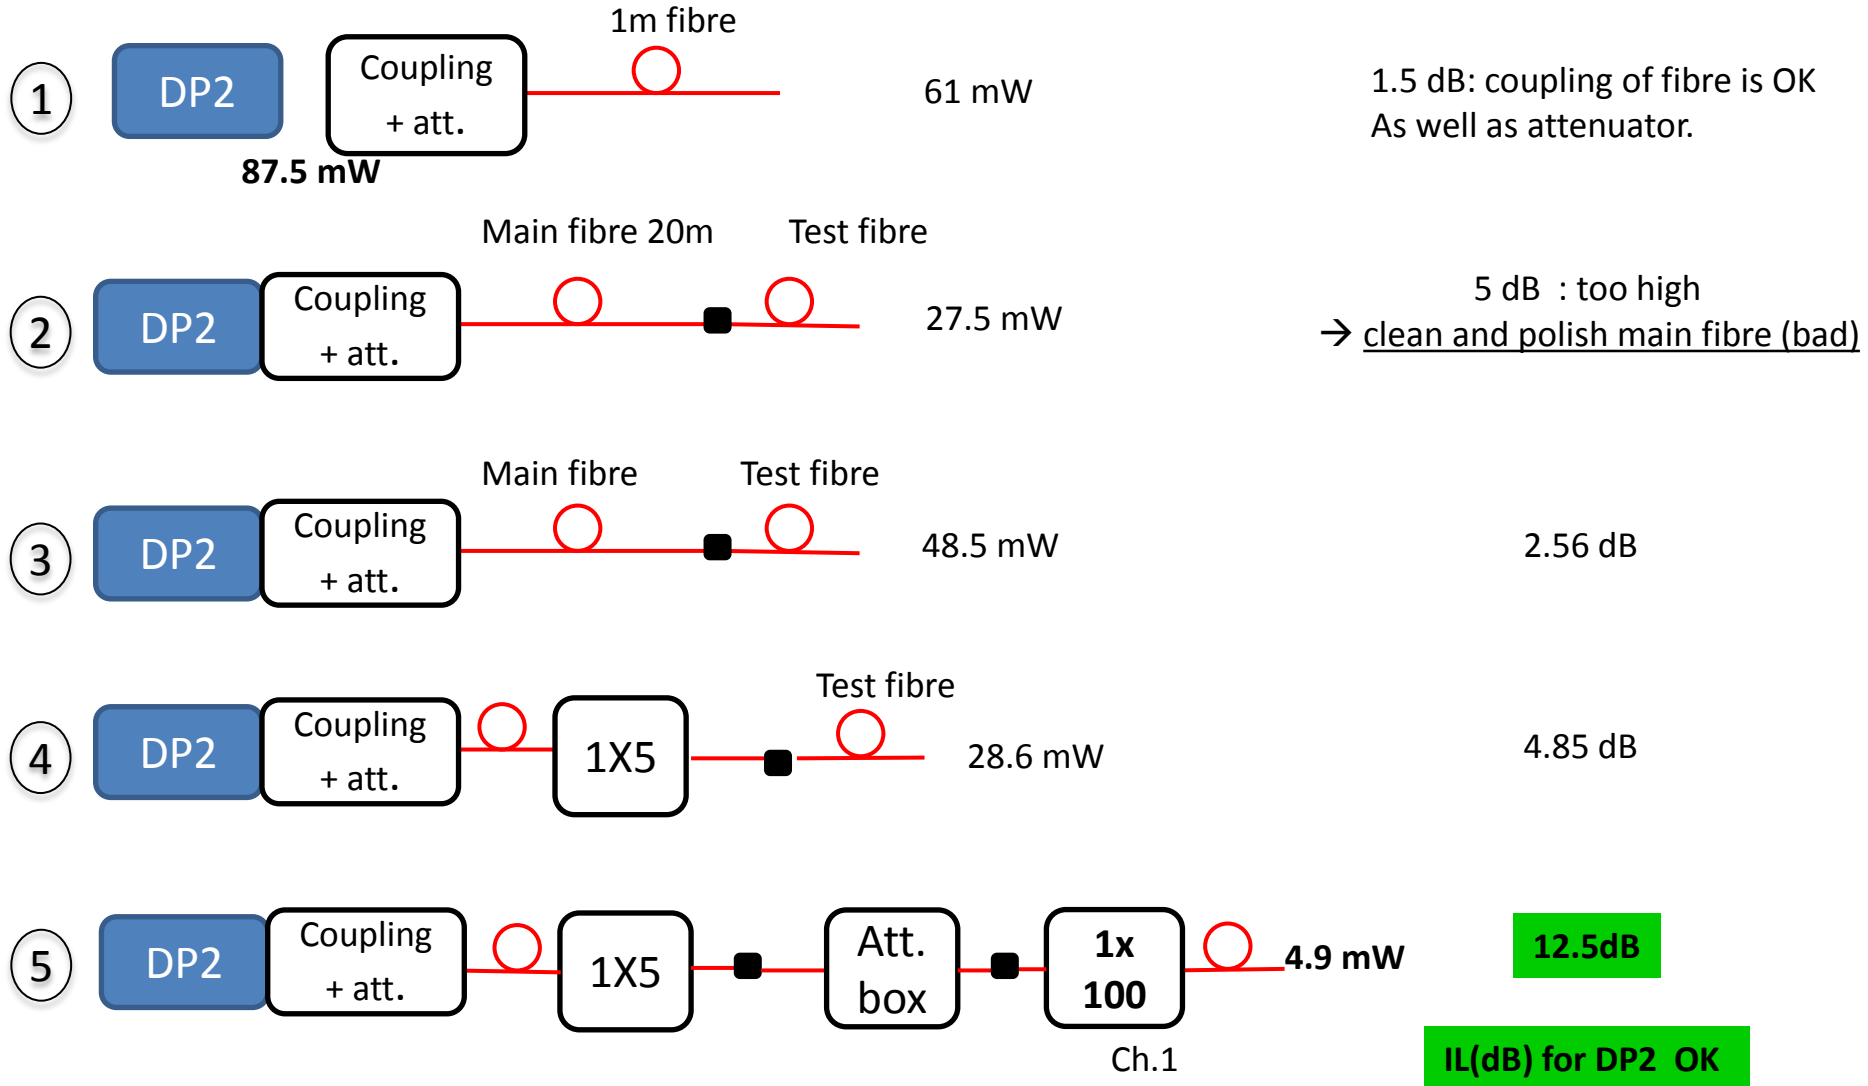
Setup to check DP2 laser path

- 1) clean and polish some fibre in the chain: some of them were bad.
- 2) TiS attenuation was OK: main fibre and full chain OK
- 3) DP2 attenuation was BAD: main fibre dirty.

- Decrease the internal attenuation from 100 to 40%;
- Wait before decreasing the current at the same time because now useless to have high current;
- Change the external attenuation
