New YLF LBO → water pipe connector broken

Nd:YLF LASERS 2

Nd:YLF LASER PUMPED TI:S LASERS 2

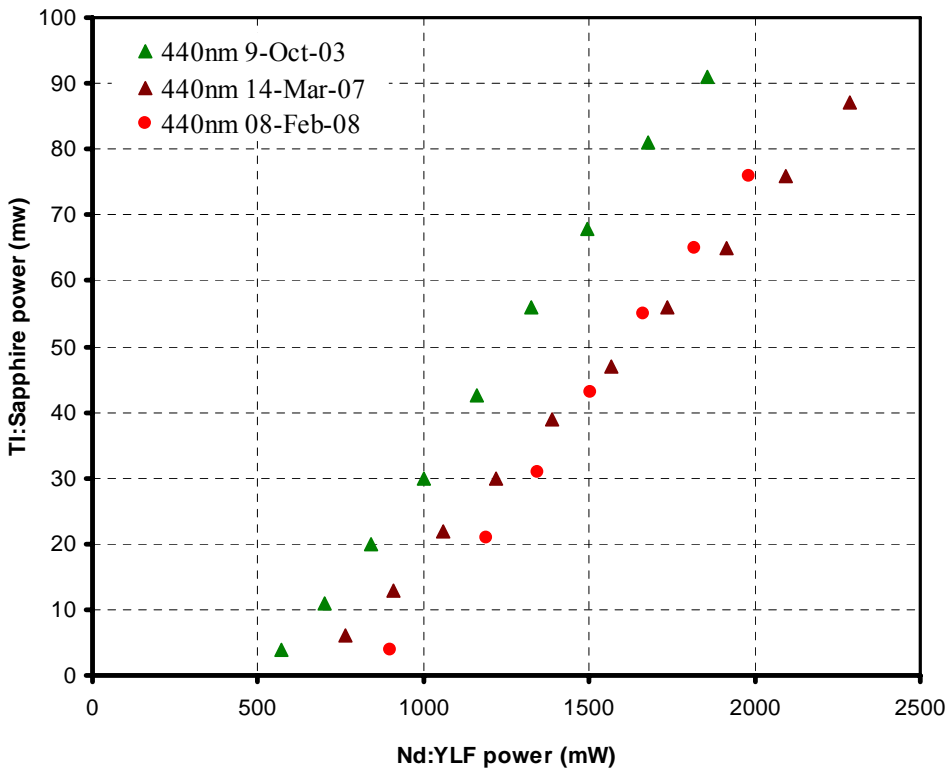
Detail of TiS tuning

problem: go lasing with Trigger disconnected (20A)

solution: rotate the $\lambda/4$ plate and tune again.

power decrease of 10mW by rotating the $\lambda/4$ plate.
