# Lasers status since 23 May

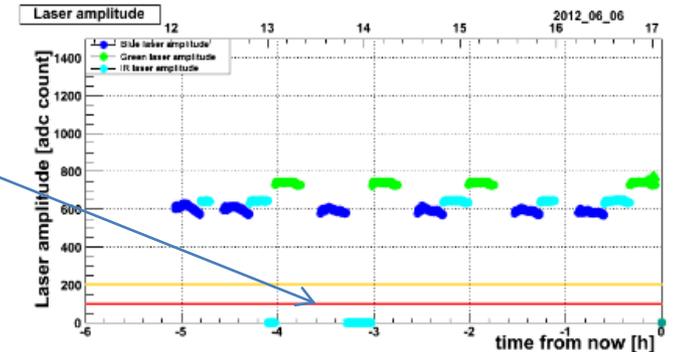
**7 June:** No more laser 1 during ~2.5hrs. same time as a CMS electrical glitch. Emanuele intervention : action on the YLF shutter itself solved the problem. [Elog770101](#)

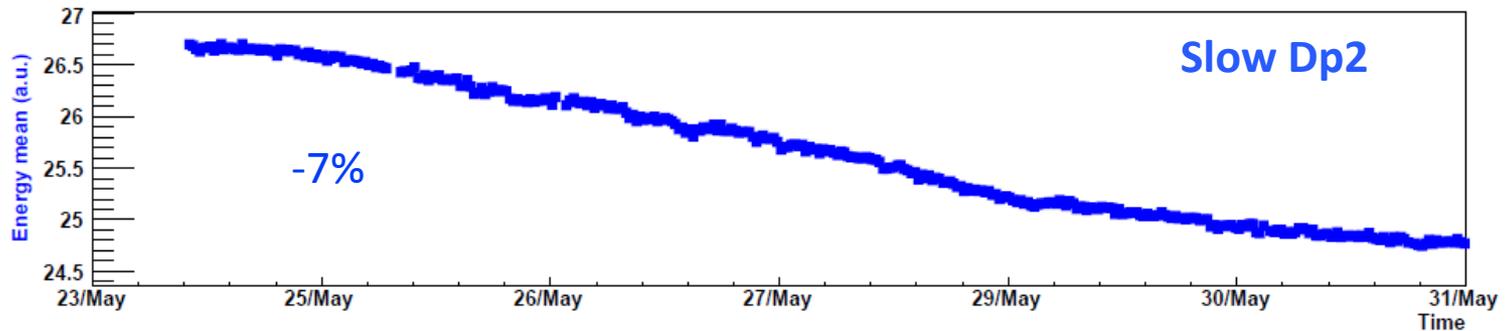
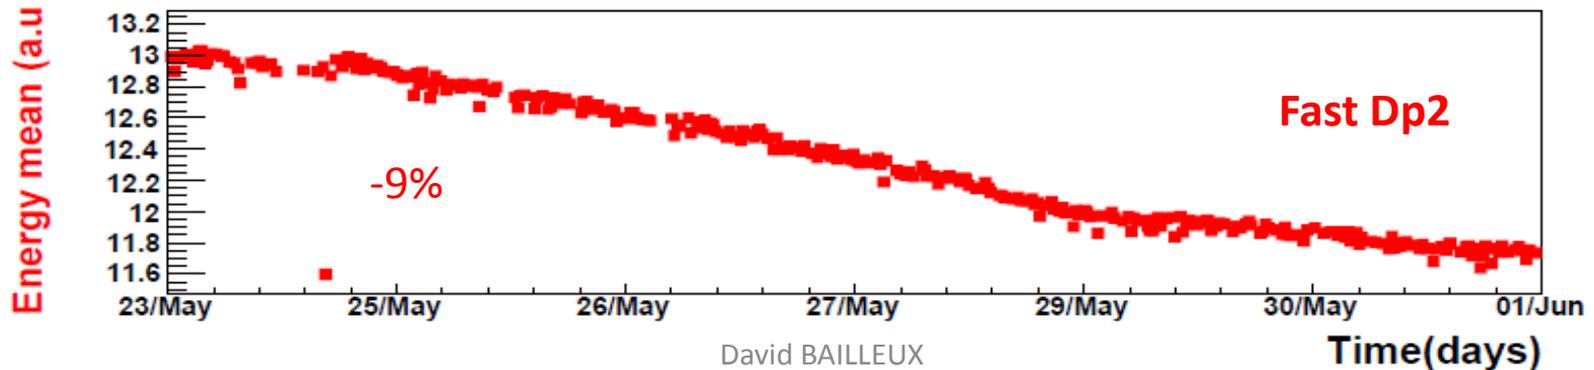
## 2) Photonics:

26 April	16 May before intervention	11 June
1) DP2-447 output:	87 mW	84 mW	89 mW
2) Before shutter :		70 mW <i>-0.8dB</i>	<b>67.3 mW <i>-1.2dB</i></b>
3) After shutter:	82mW	65 mW <i>-1.1dB</i>	62.3 mW <i>-1.55 dB</i>
4) After 1m fibre:	61 mW <b>-1.54 dB</b>	48 mW <b>-2.43 dB</b>	<b>fibre untouched.</b>

Same power before and after chiller replacement

Power is quite consistent with 16 May and the power loss since 16 May doesn't explain the overall loss since 26 April. → 2 suspicious places : from optics but also from fibre again.

**11 June:** New chiller on the morning. [Elog770688](#)

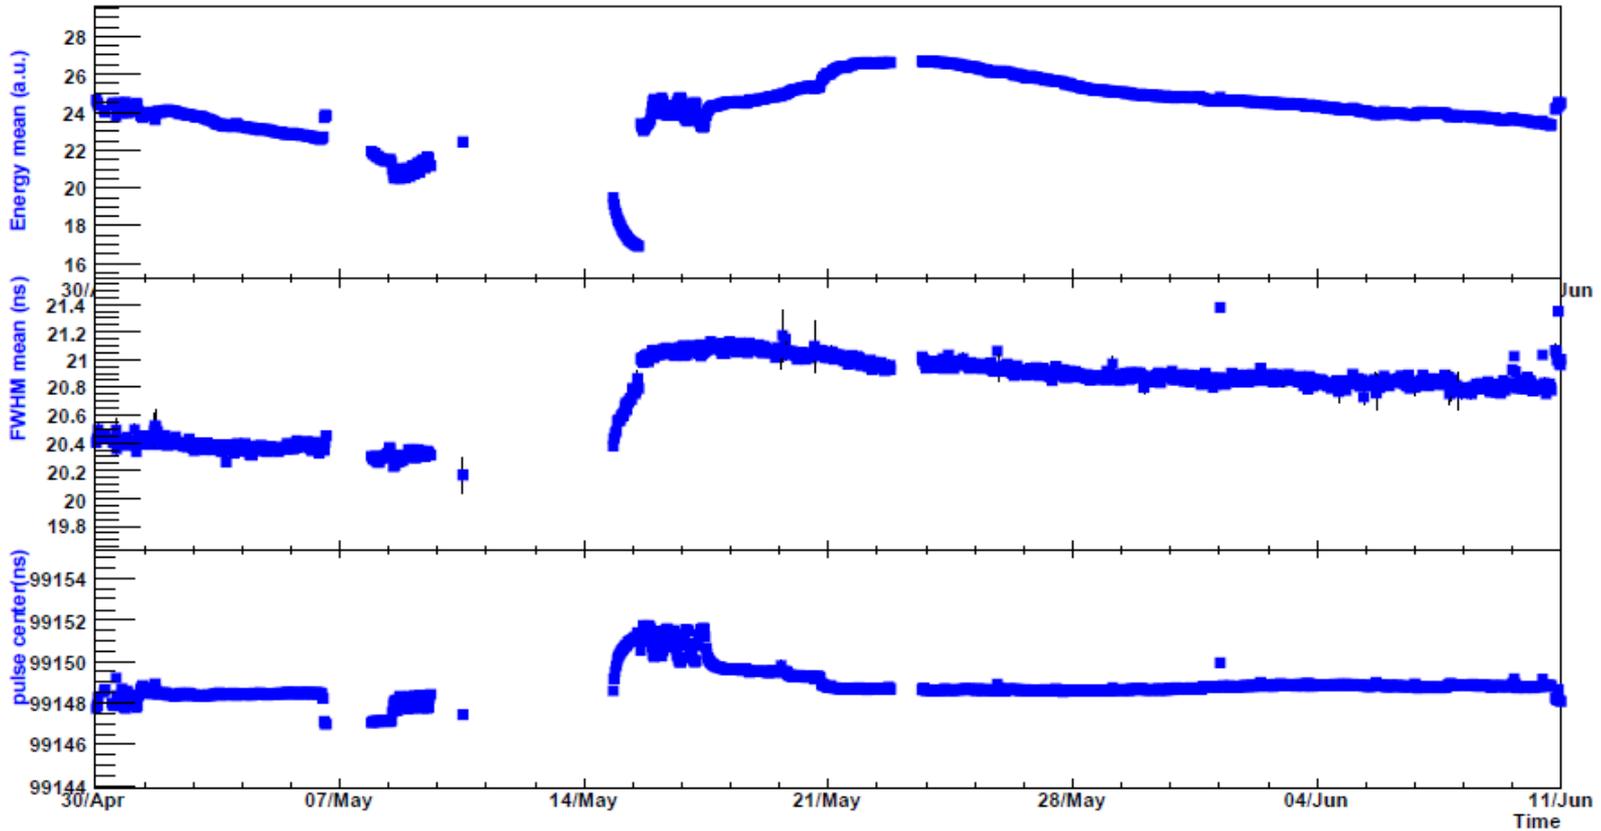
DP2-447 history

- Linear attenuator went in faulty – unknown position. Nothing was touch the 11 June ! Power was well consistent when operating remotely (from 40 to 80% as 11 June). The regular degradation over time could be linked to this attenuator if position was not fixed or problem at 40%..
- To be included a reset button on the DP2 GUI as for the main linear attenuator.
- Wrong origin value on the GUI: origin is 0% not 100%.
- Suspicious part: 3 optical mirrors.
